NBSIR 79-1597

Examination of Components from a Mahler-Weber PJ-260 Aircraft

Failure Analysis Report

September 1978
Issued January 1979

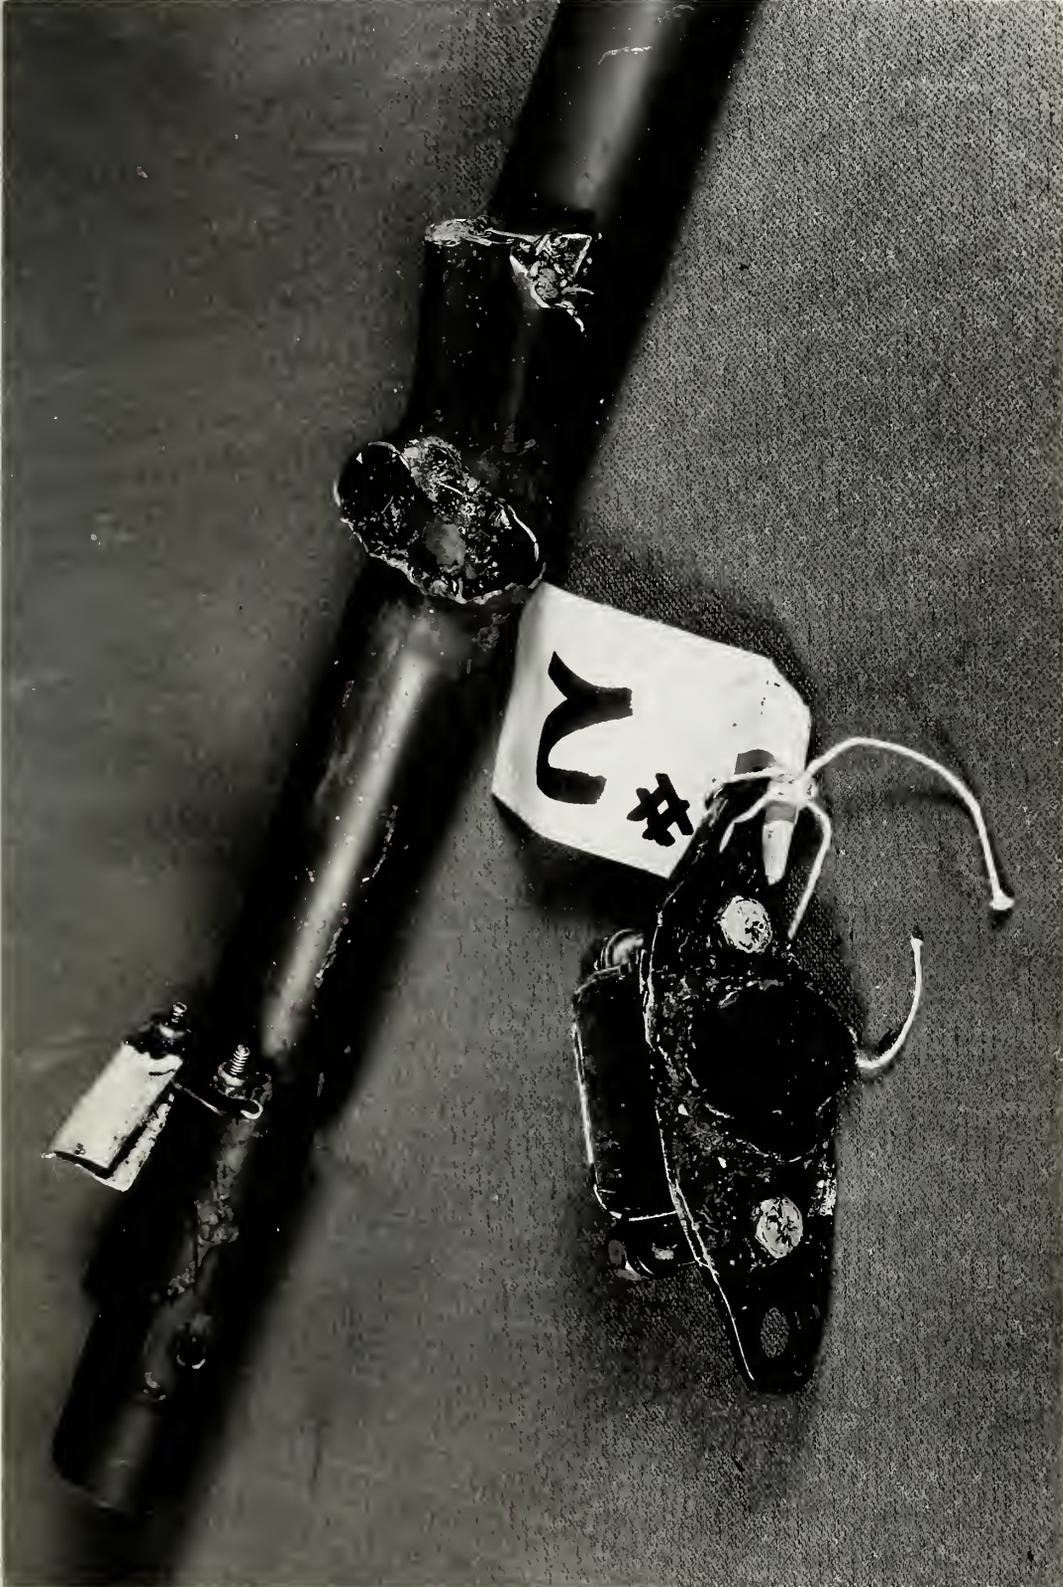
For the fracture between parts nos. 1 and 2, the fracture had passed through part no. 1 adjacent to the point where the two parts had been welded together. Both fracture surfaces had suffered considerable mechanical damage as can be seen in figure 2 where both fracture surfaces are shown. In addition to the mechanical damage, there was a black deposit on the fracture surfaces and on the surrounding areas. The fracture surface remaining with part no. 2 was selected for examination with the SEM. It was cleaned ultrasonically with paint remover to remove the black deposit, and then with petroleum ether. There appeared to be some corrosion product on the fracture surface, so some further cleaning was undertaken with ammonium citrate to remove the rust. An SEM fractograph from this part is shown in figure 3. The fracture mode is unclear.

Figure 2. Fracture surfaces of part no. 1 (top) and part no. 2 (bottom) as received at NBS. X 1/2

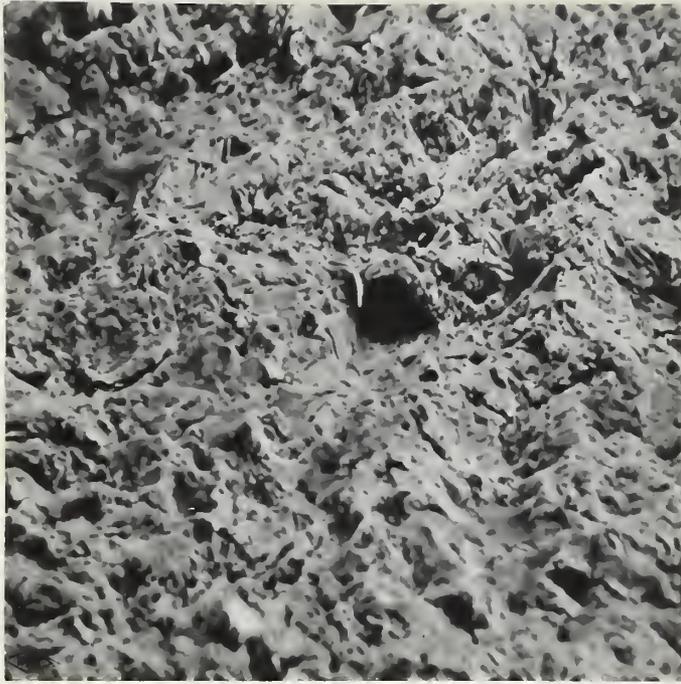
Figure 3. Representative SEM fractograph from part no. 2. X 900

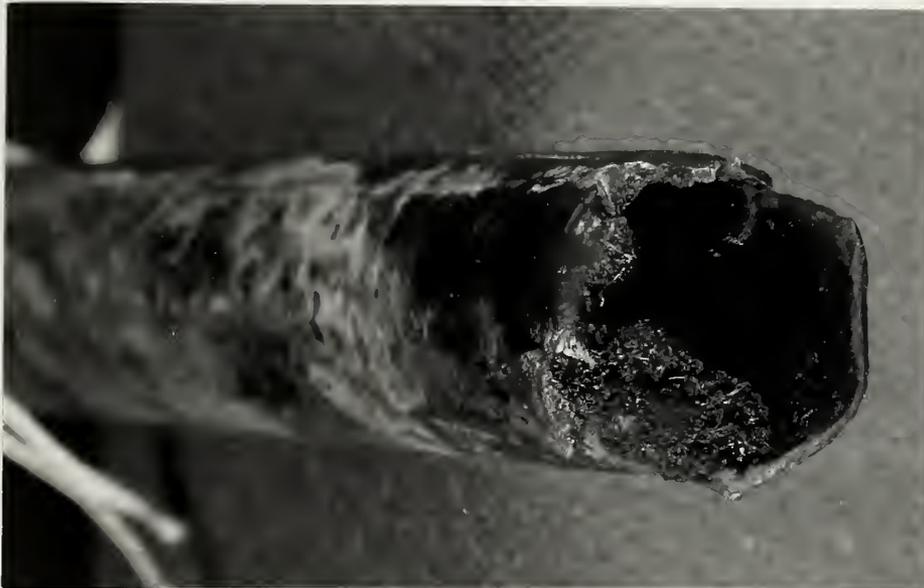
Among parts nos. 3, 4 and 5, the fracture surface of part no. 5 appeared to be in the best condition, even though the material was rather severely deformed adjacent to the fracture, and the fracture itself had suffered considerable mechanical damage. The fracture surface of part no. 5 was the only one of this group that was examined with the SEM. It is shown in figure 4 as it was received at NBS. In the region of the fracture that had not been damaged, dimpled rupture was the fracture mode. A representative fractograph is shown in figure 5.

Figure 4. Fracture surface of part no. 5 as received at NBS. X 2

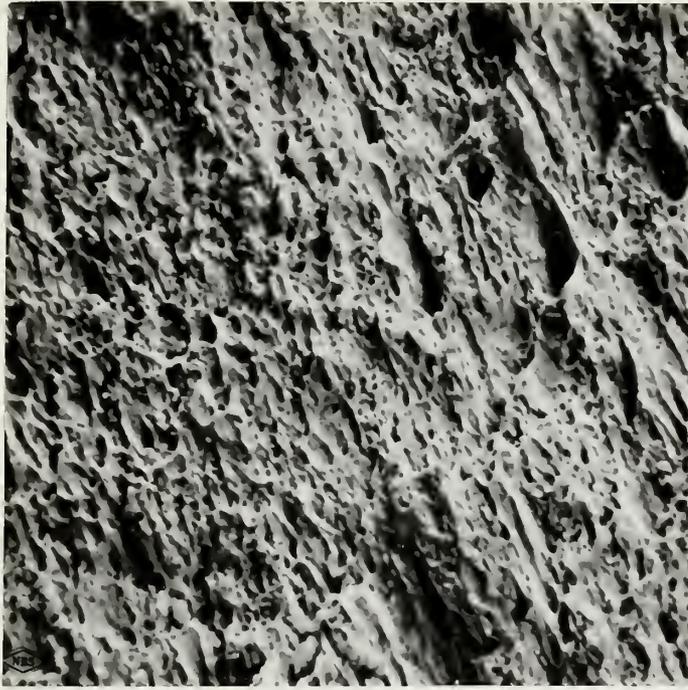
Figure 5. Representative SEM fractograph from part no. 5. Dimpled rupture is the primary fracture mode. X 950

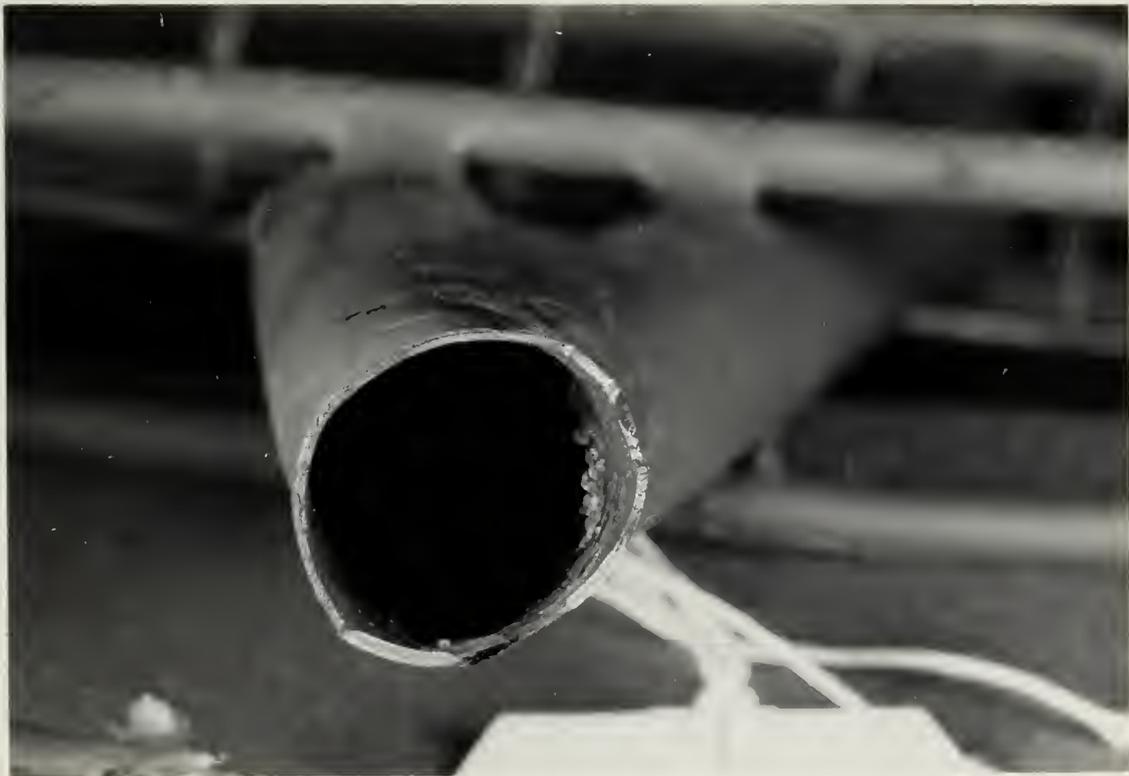
For the fracture between parts nos. 6 and 7, the fracture passed through part no. 7 close to the point where part nos. 6 and 7 were welded together. The fracture surface of the major portion of part no. 7 was examined with the SEM. As can be seen in figure 6, this fracture exhibited much less mechanical damage than the previous two fractures that were discussed. Dimpled rupture was the fracture mode exhibited. A representative fractograph is shown in figure 7.

Figure 6. Fracture surface of part no. 7 as received at NBS. X 2

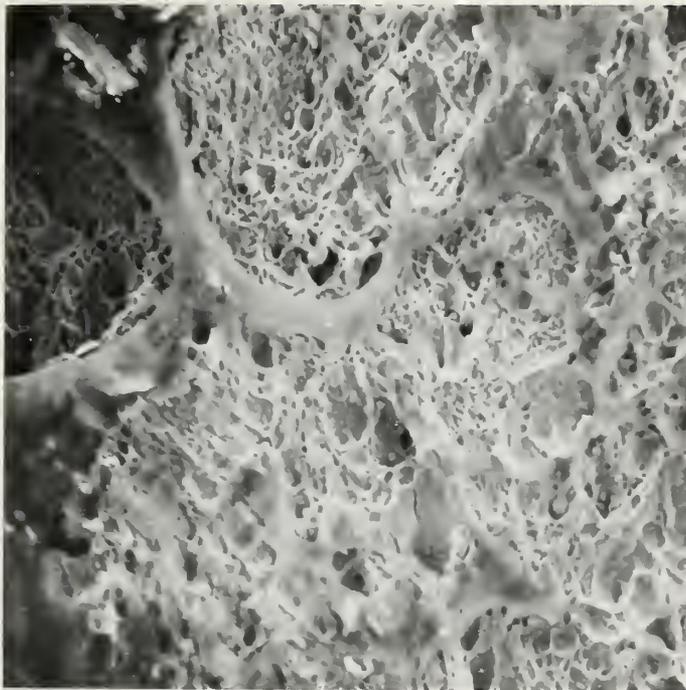
Figure 7. Representative SEM fractograph from part no. 7. Dimpled rupture is the primary fracture mode. X 550

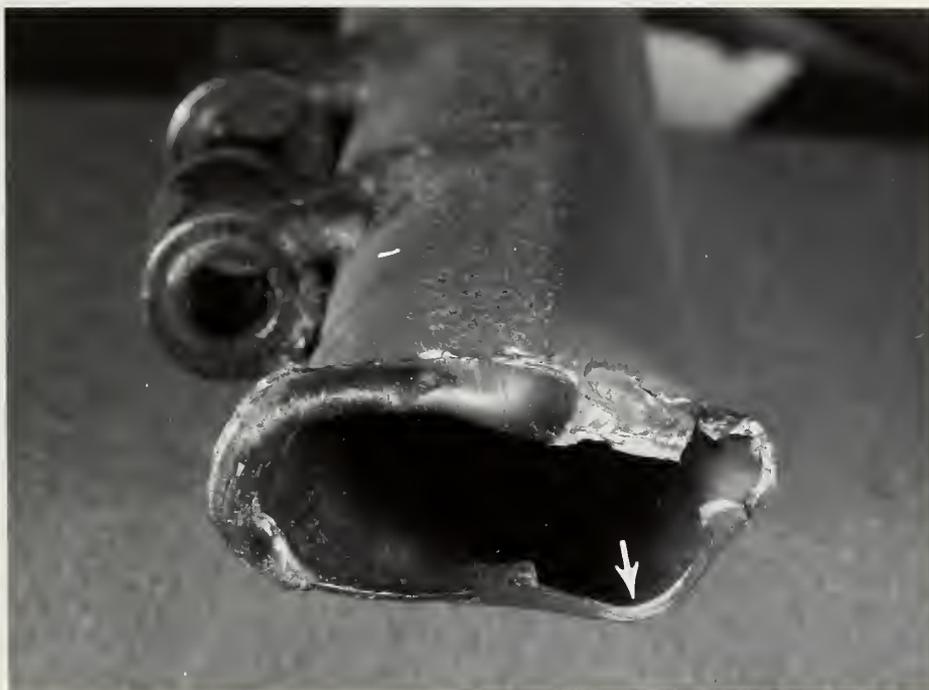
For the fracture between parts nos. 8 and 9, the fracture surface of the major portion of part no. 9 was examined with the SEM. This fracture is shown in figure 8 as it was received at NBS. As can be seen in the figure, the fracture exhibited rather severe mechanical damage. In a region where there was very little mechanical damage, there was evidence

of apparent fatigue striations. This region is indicated by the arrow in figure 8. Two fractographs showing examples of the striations appear in figures 9 and 10. The remaining part of the fracture that was examined with the SEM exhibited dimpled rupture as the fracture mode. A representative fractograph is shown in figure 11.

There was evidence of fatigue striations on the fracture surface of component no. 9 indicating that a crack had initiated and propagated some distance via fatigue before the time of the accident. The fatigue portion of the fracture passed through material that was close to the weld that connected part nos. 8 and 9.

Figure 8. Fracture surface of part no. 9 as received at NBS. Arrow indicates region of apparent fatigue striations as shown in figures 9 and 10. X 2

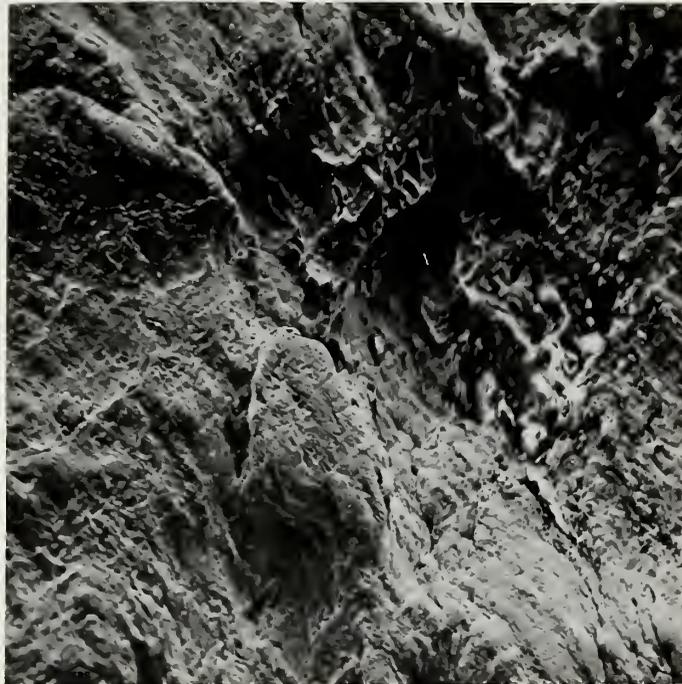
1. The fracture surface of part no. 9 exhibited apparent fatigue striations indicating that fracture probably initiated via a fatigue crack.
2. The fracture surfaces of all the other components that were examined exhibited dimpled rupture indicating ductile overload as the fracture mechanism.
3. Part no. 12 exhibited significant secondary cracking. This cracking was likely present before the failure of the aircraft.
4. Part no. 12 exhibited a significant number of large, detrimental longitudinal inclusions.
5. Several of the fractures occurred in the vicinity of welds connecting two components.

Figure 9. SEM fractograph from the region of the fracture of part no. 9 indicated by the arrow in figure 8. Apparent fatigue striations are evident. X 610

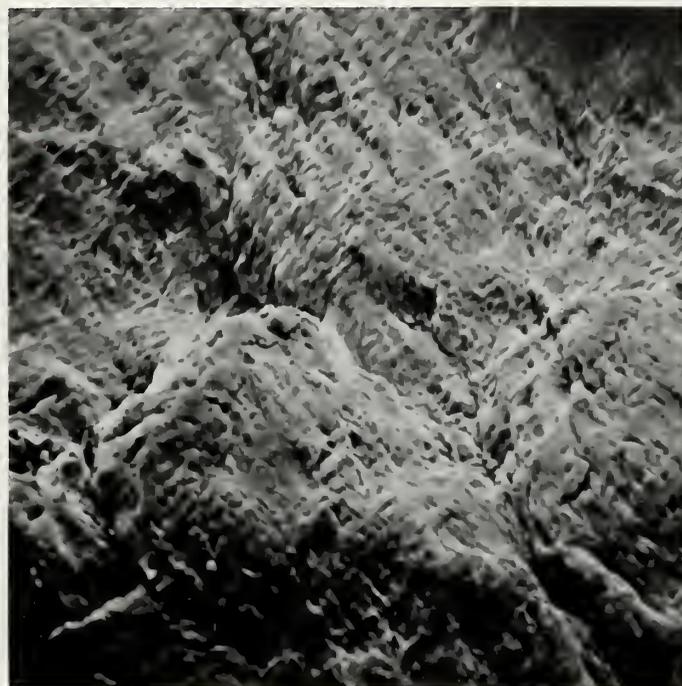
Figure 10. SEM fractograph from another area of the region indicated by the arrow in figure 8. Apparent fatigue striations are evident. X 1210

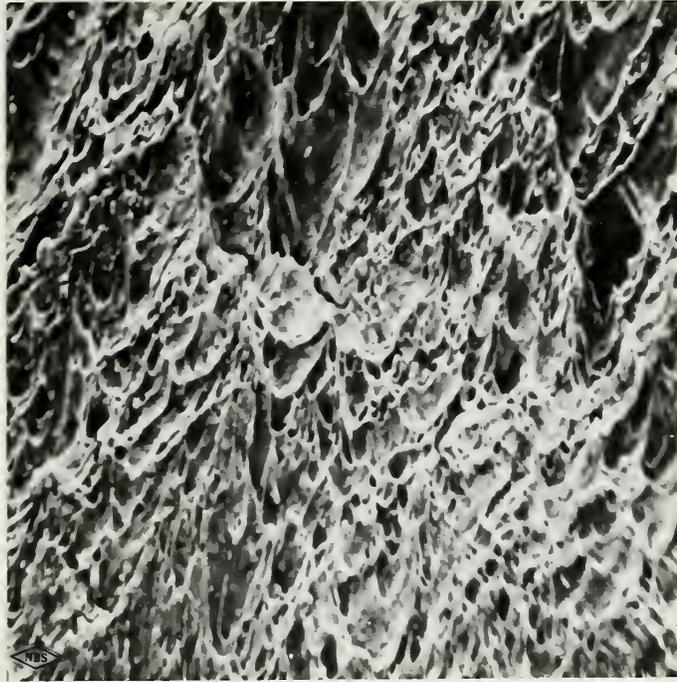
Figure 11. Representative SEM fractograph from an area away from that indicated by the arrow in figure 8. The primary fracture mode is dimpled rupture. X 1300

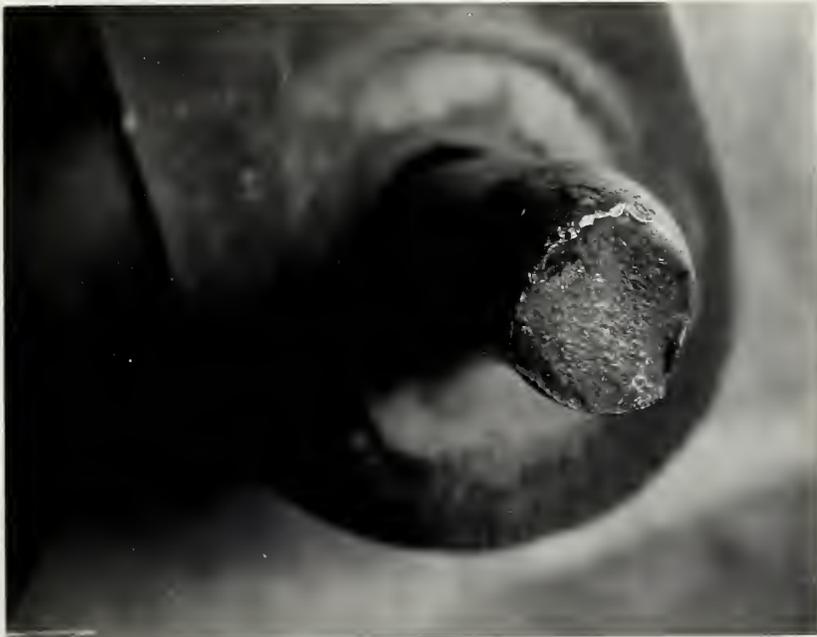
For the fracture between parts nos. 10 and 11, part 10 was selected for examination with the SEM. The fracture surface of part no. 10 is shown as received at NBS in figure 12. There was considerable deformation adjacent to the fracture of this part, and there was some necking. The fracture mode exhibited by the fracture was dimpled rupture. A representative fractograph is shown in figure 13.

Figure 12. Fracture surface of part no. 10 as received at NBS. X 5

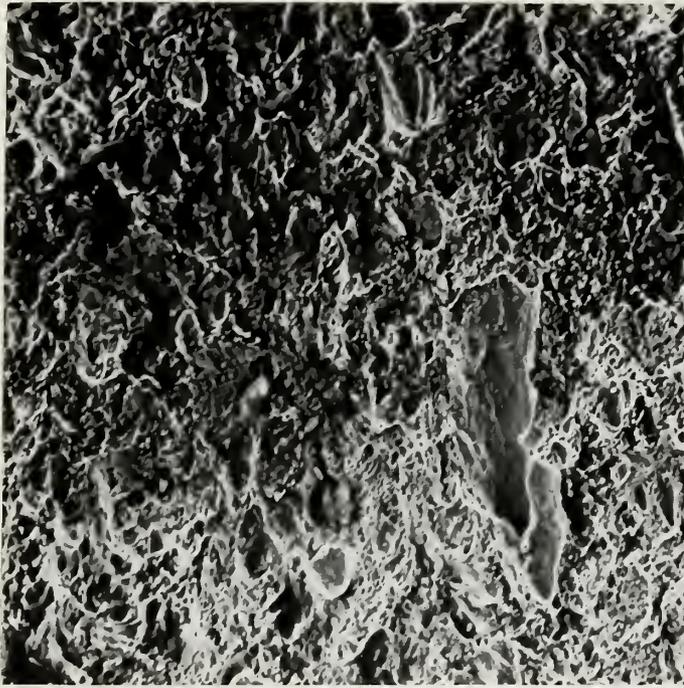
Figure 13. Representative SEM fractograph from part no. 10. The primary fracture mode is dimpled rupture. X 1100

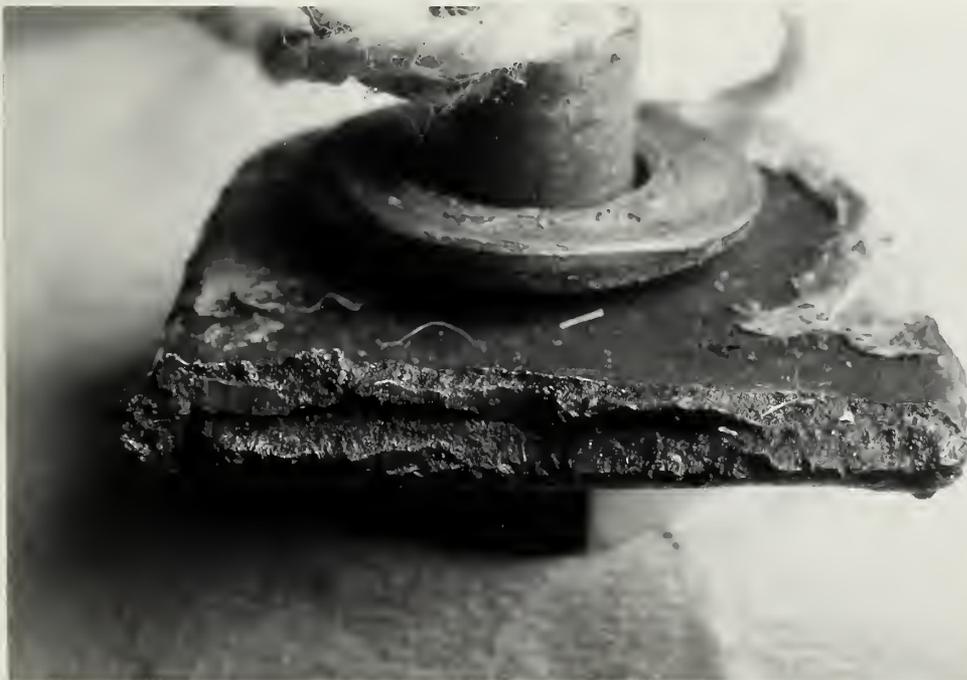
The fracture surface of part no. 12 is shown in figure 14 as it was received at NBS. This fracture had been rather severely damaged mechanically and many of the fracture features had been obliterated. Nevertheless, dimpled rupture could be seen as the fracture mode. A representative fractograph is shown in figure 15.

As can be seen in figure 14, part no. 12 consisted of two layers of steel at the fracture. At the location where the part was sectioned, there was some deformation adjacent to the fracture, but very little necking. The fracture profiles of the two layers are shown in figures 25a and 25b. There was no significant secondary cracking in the section shown in figure 25a. There was a small amount of secondary cracking adjacent to the fracture in the layer shown in figure 25b, but away from the fracture, there was significant secondary cracking. Some of this cracking can be seen in figure 26 at a magnification of 100X. At higher magnifications, e.g., 500X, it appeared that the grains in the microstructure terminate at the cracks, which would imply that the cracks were present before the material was heat treated. In addition to the cracking, there are a number of longitudinal stringer type inclusions that parallel the one indicated by the arrow in figure 26. In some places, the secondary cracking follows the inclusions.

Figure 14. Fracture surface of part no. 12 as received at NBS. X 5

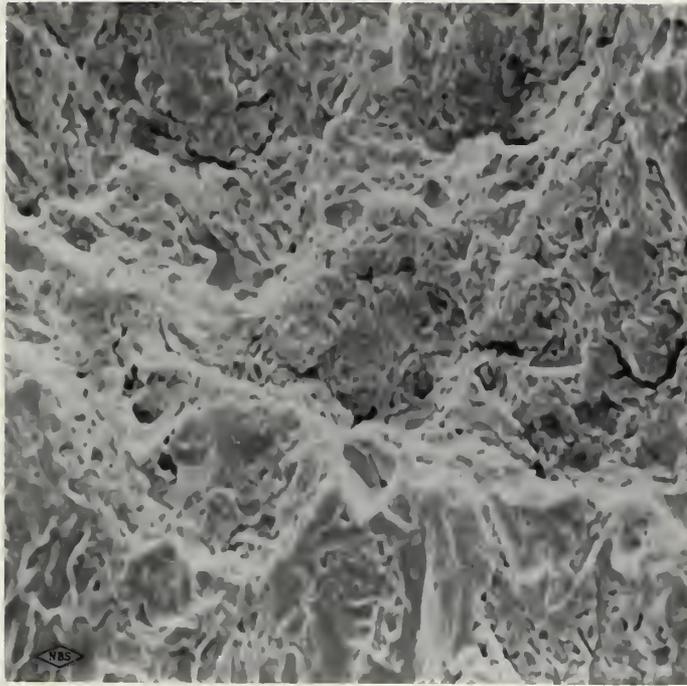
Figure 15. Representative SEM fractograph from part no. 12. The primary fracture mode exhibited here is dimpled rupture. X 925

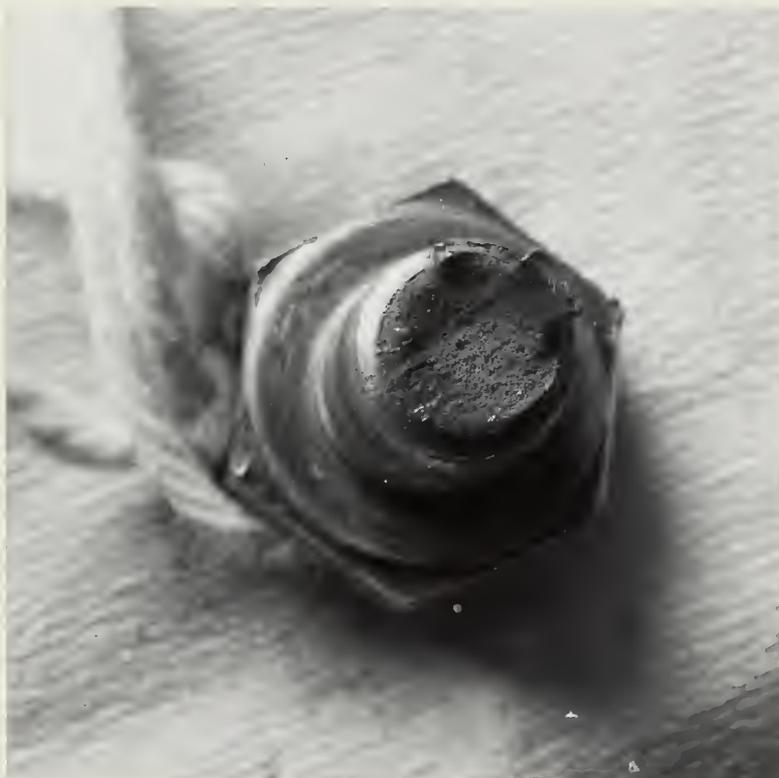
The fracture surface of part no. 17 is shown in figure 16 as it was received at NBS. This part did not exhibit the degree of macroscopic deformation and necking that can be seen in part no. 10. The fracture mode exhibited by part no. 17 was dimpled rupture. A representative fractograph is shown in figure 17.

Figure 16. Fracture surface of part no. 17 as received at NBS. X 5

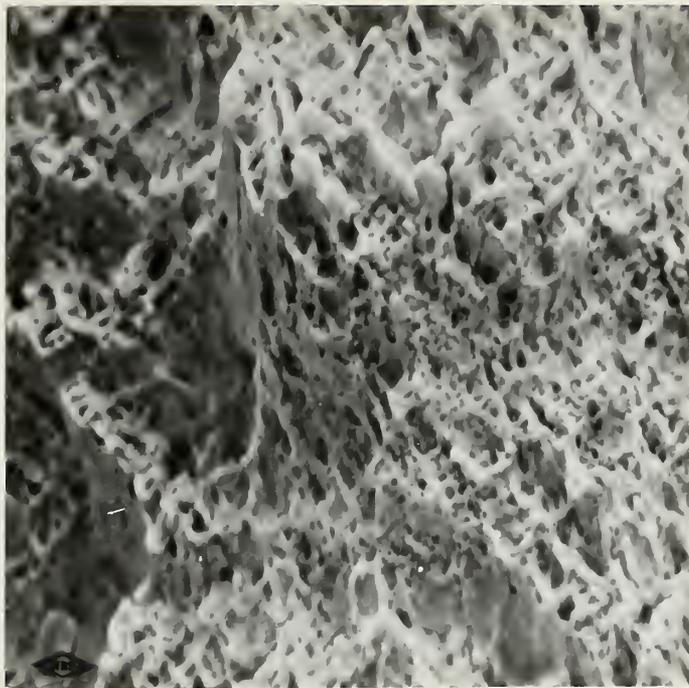
Figure 17. Representative SEM fractograph from part no. 17. The primary fracture mode exhibited is dimpled rupture. X 1000

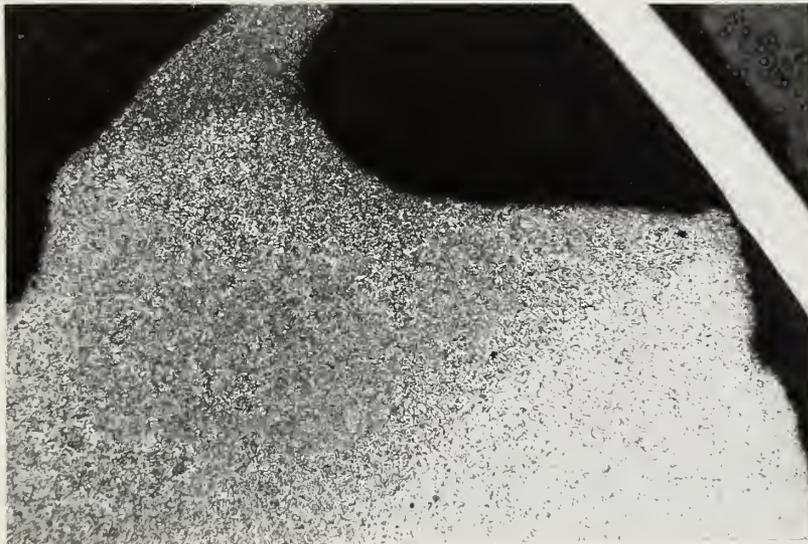
A longitudinal section through the fracture surface of part no. 1 that was attached to part no. 2 showing the fracture profile appears in figure 18. At this location, the fracture passed through the heat affected zone in part no. 1 adjacent to the weld connecting part nos. 1 and 2. A considerable amount of deformation is exhibited adjacent to the fracture near the outside surface of part no. 1 (left side of the fracture profile in figure 18), but very little deformation is evident adjacent to the rest of the fracture profile. The fracture profile is relatively smooth. A higher magnification examination revealed no significant secondary cracking.

Figure 18. Longitudinal section intersecting the fracture attached to part no. 2. The fracture profile is at the top in the figure. Deformation is present at the left at the fracture. The fracture passes through the heat affected zone of the weld connecting part nos. 1 and 2. Etchant: 4% picral X 80

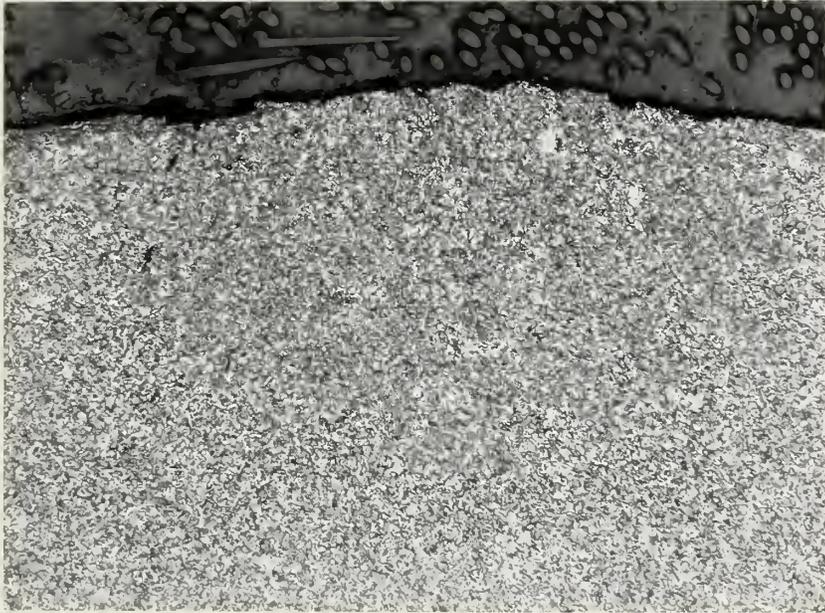
Part of the fracture profile of part no. 5 is shown in figure 19. There was a significant amount of deformation at the fracture adjacent to both the inside and the outside surfaces of the tubing. The fracture profile is relatively smooth and there is no significant secondary cracking.

Figure 19. Section through part no. 5 showing the fracture profile (horizontal at the top).
Etchant: 4% picral X 200

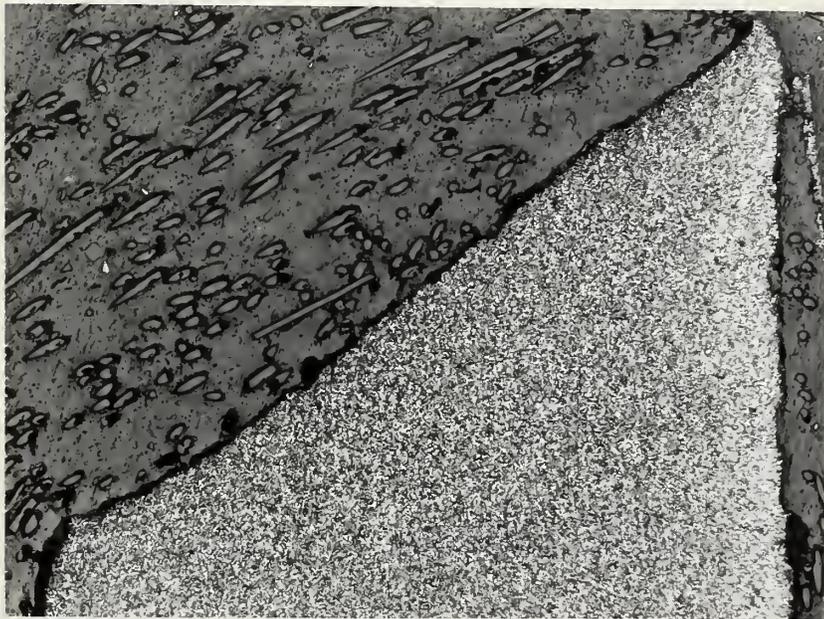
The fracture profiles in two longitudinal sections through part no. 7 are shown in figures 20 and 21. The outside of the tubing wall is at the right in figure 20 and at the left in figure 21. In both locations, the

fracture profile is about 45° to the longitudinal axis of the tubing. In figure 21, the fracture appears to pass through the heat affected zone of the weld connecting part nos. 6 and 7 together, whereas in figure 20, the fracture passes through material that appears to have no visual effects from the welding operation -- hence, the difference in the microstructure between the two figures. Some macroscopic deformation was evident near the fracture in both sections. There was no significant secondary cracking.

Figure 20. Longitudinal section through part no. 7 showing the fracture profile at the top. In this location, the fracture passed through material that shows no visual effects from welding.
Etchant: 4% picral X 100

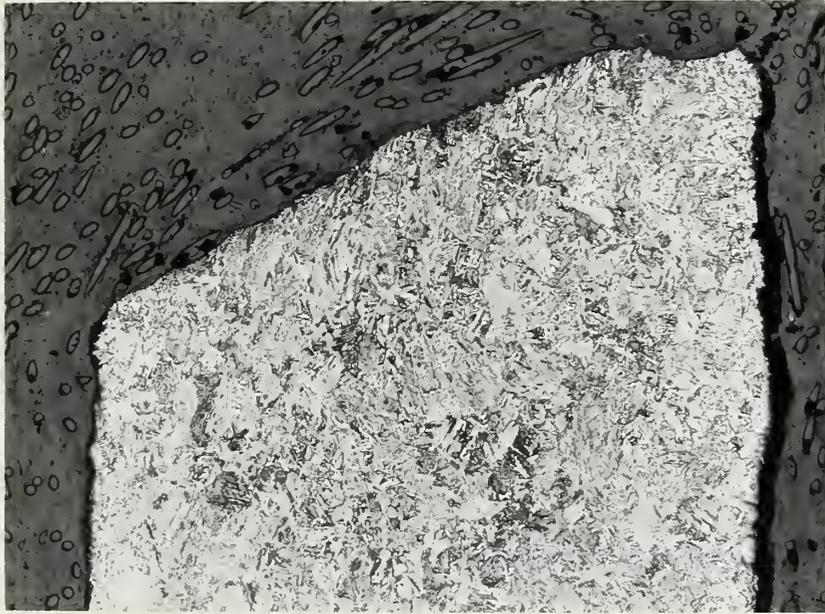
Figure 21. Longitudinal section through part no. 7 showing the fracture profile at the top. In this location, the fracture passed through what appeared to be the heat affected zone of the weld connecting part nos. 6 and 7.
Etchant: 4% picral X 100

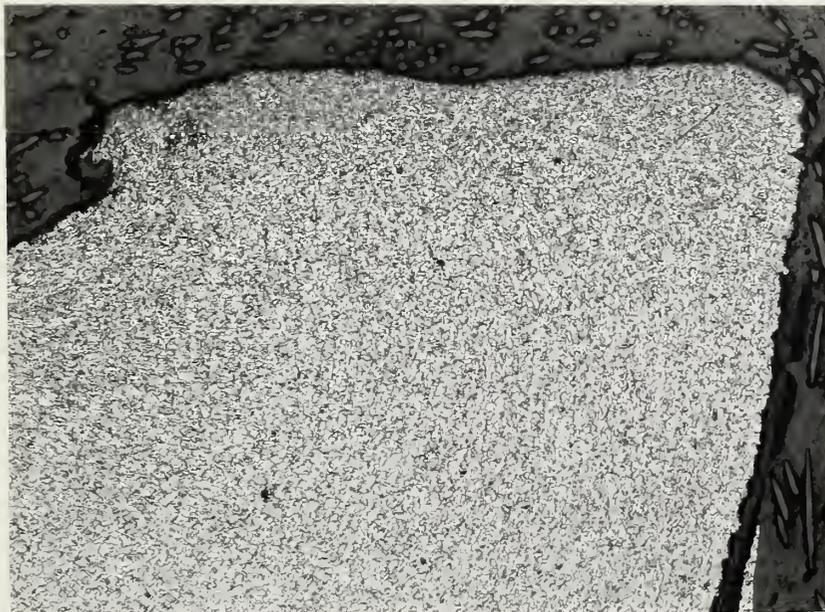
Two longitudinal sections through part no. 9 showing the fracture profile appear in figures 22 and 23. The section shown in figure 22 was taken through the region of the fracture where apparent fatigue striations were detected. There was some deformation evident in the section shown in figure 23, but very little in the section shown in figure 22. The fracture profile in figure 22 is much smoother than that of figure 23. The reason for the difference in microstructure between the two sections is analogous to that given above for part no. 7 -- namely, in figure 23, the fracture passed through the heat affected zone of the weld connecting part nos. 8 and 9, whereas in figure 22, the fracture passed through material apparently unaffected by the welding operation. There was no significant secondary cracking.

Figure 22. Longitudinal section through part no. 9 where apparent fatigue striations were detected. The fracture profile is at the top. At this location, the fracture passed through material that exhibited no visible effects from the welding operation.
Etchant: 4% picral X 100

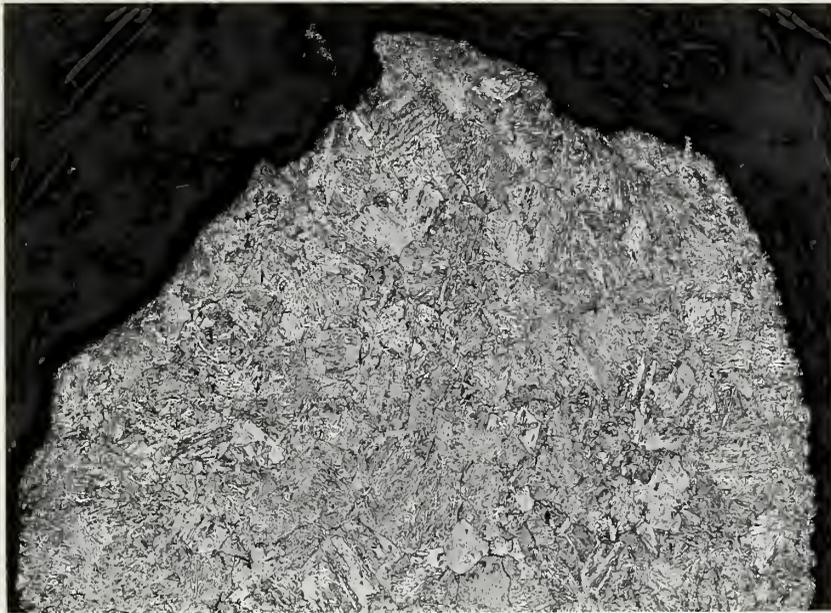
Figure 23. Longitudinal section through part no. 9 where the fracture mode was primarily dimpled rupture. At this location, the fracture passed through the heat affected zone of the weld connecting part nos. 8 and 9.
Etchant: 4% picral X 100

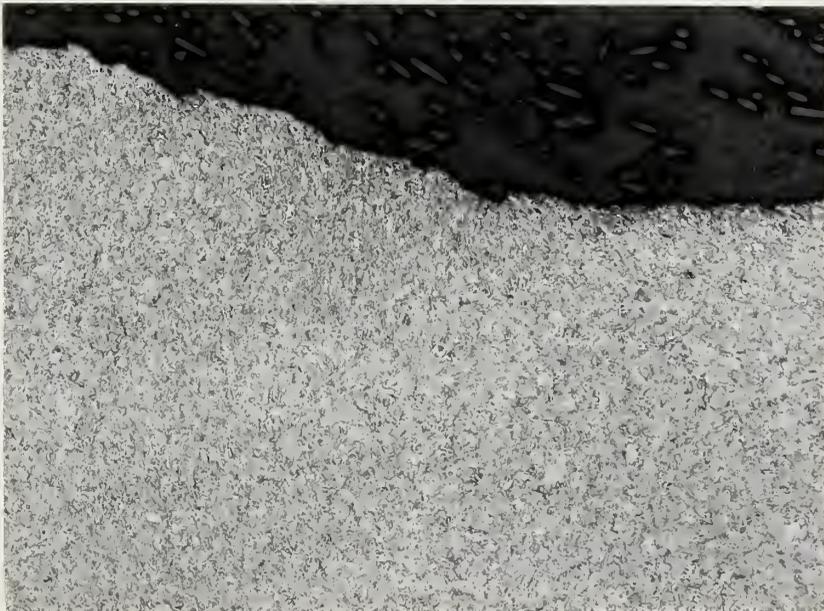
A longitudinal section through part no. 10 showing a portion of the fracture profile appears in figure 24. There was a considerable amount of deformation and necking in the vicinity of the fracture. There was no significant secondary cracking.

Figure 24. Longitudinal section through part no. 10 showing the fracture profile at the top.
Etchant: 4% picral X 100

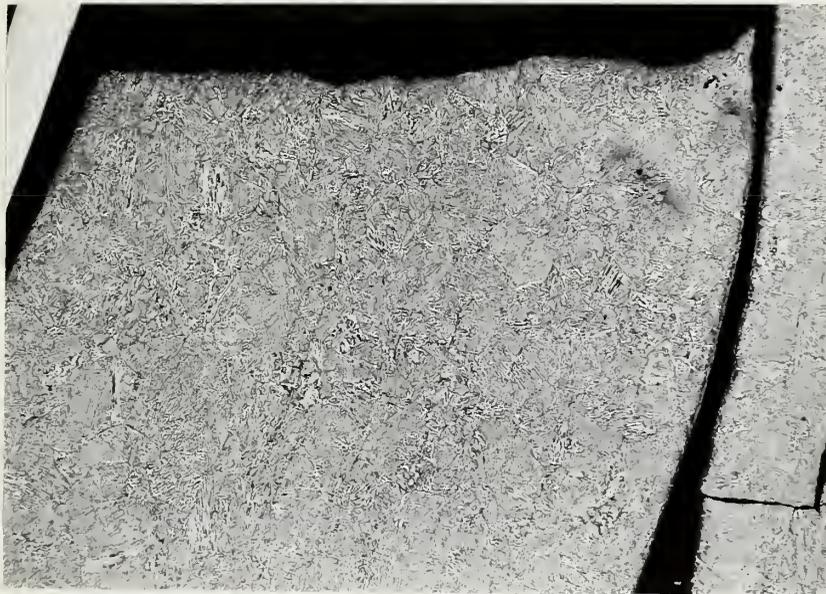
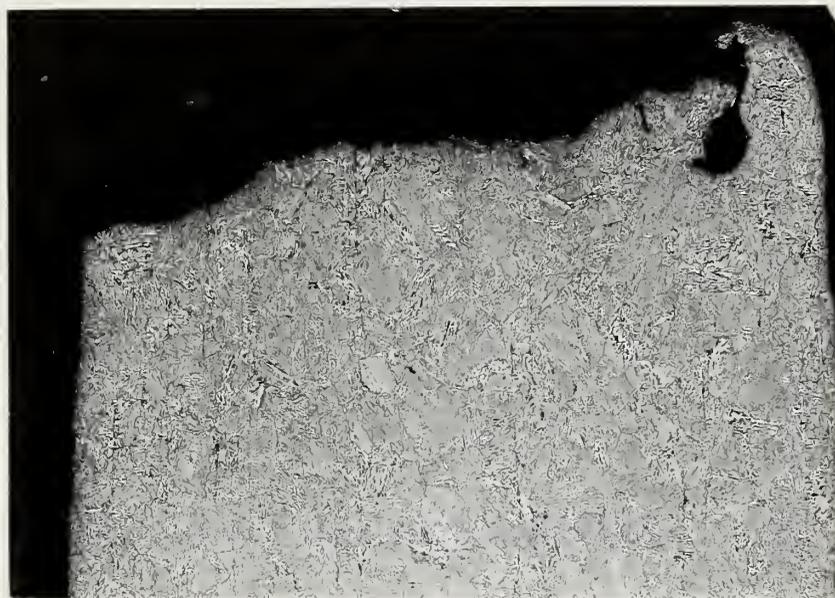
Figure 25. Fracture profiles of the two layers of part no. 12. The fracture profiles are at the top in figures a and b. The layer shown in figure b exhibited secondary cracking away from the fracture as shown in figure 26.
Etchant: 4% picral

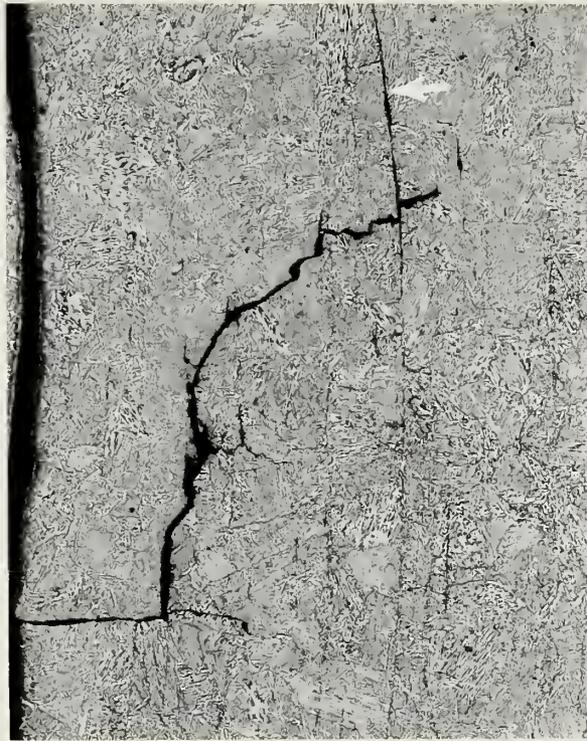
In part no. 12, the fact that the grains in the microstructure terminate at the secondary cracks suggests that the cracking was probably present before the material was heat treated. The very long longitudinal inclusions in this part are considered detrimental, but they do not appear to have contributed to the fracture.

The NTSB had requested that NBS determine whether part no. 12 or part no. 17 failed first. It was not ascertained from the results of the NBS examination which of these parts failed first. However, part no. 12 did have a defect that was apparently present before the time of the failure of the aircraft.

Figure 26. Longitudinal section through part no. 12 in a region away from the fracture showing significant secondary cracking. The field shown here is from the same section appearing in figure 25b. In addition to the secondary cracking, there are a number of long stringer type inclusions evident. These inclusions are parallel to the longitudinal axis of the part. The arrow indicates one of the inclusions.
Etchant: 4% picral X 100

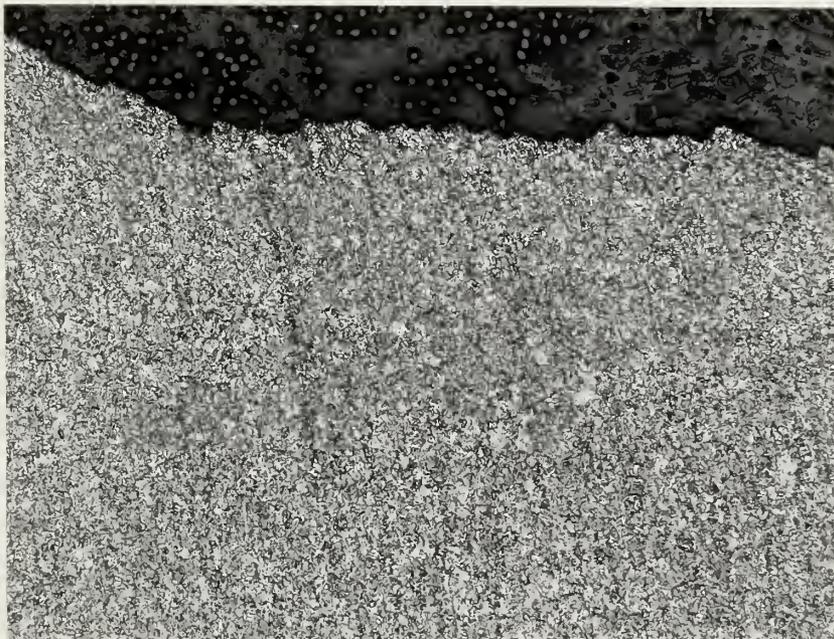
A longitudinal section through part no. 17 intersecting the fracture is shown in figure 27. There was some deformation adjacent to the fracture. There was no significant secondary cracking.

Figure 27. Longitudinal section through part no. 17 showing the fracture profile at the top.
Etchant: 4% picral X 100
